Replacement of corroded water pipes

WATER SUPPLY

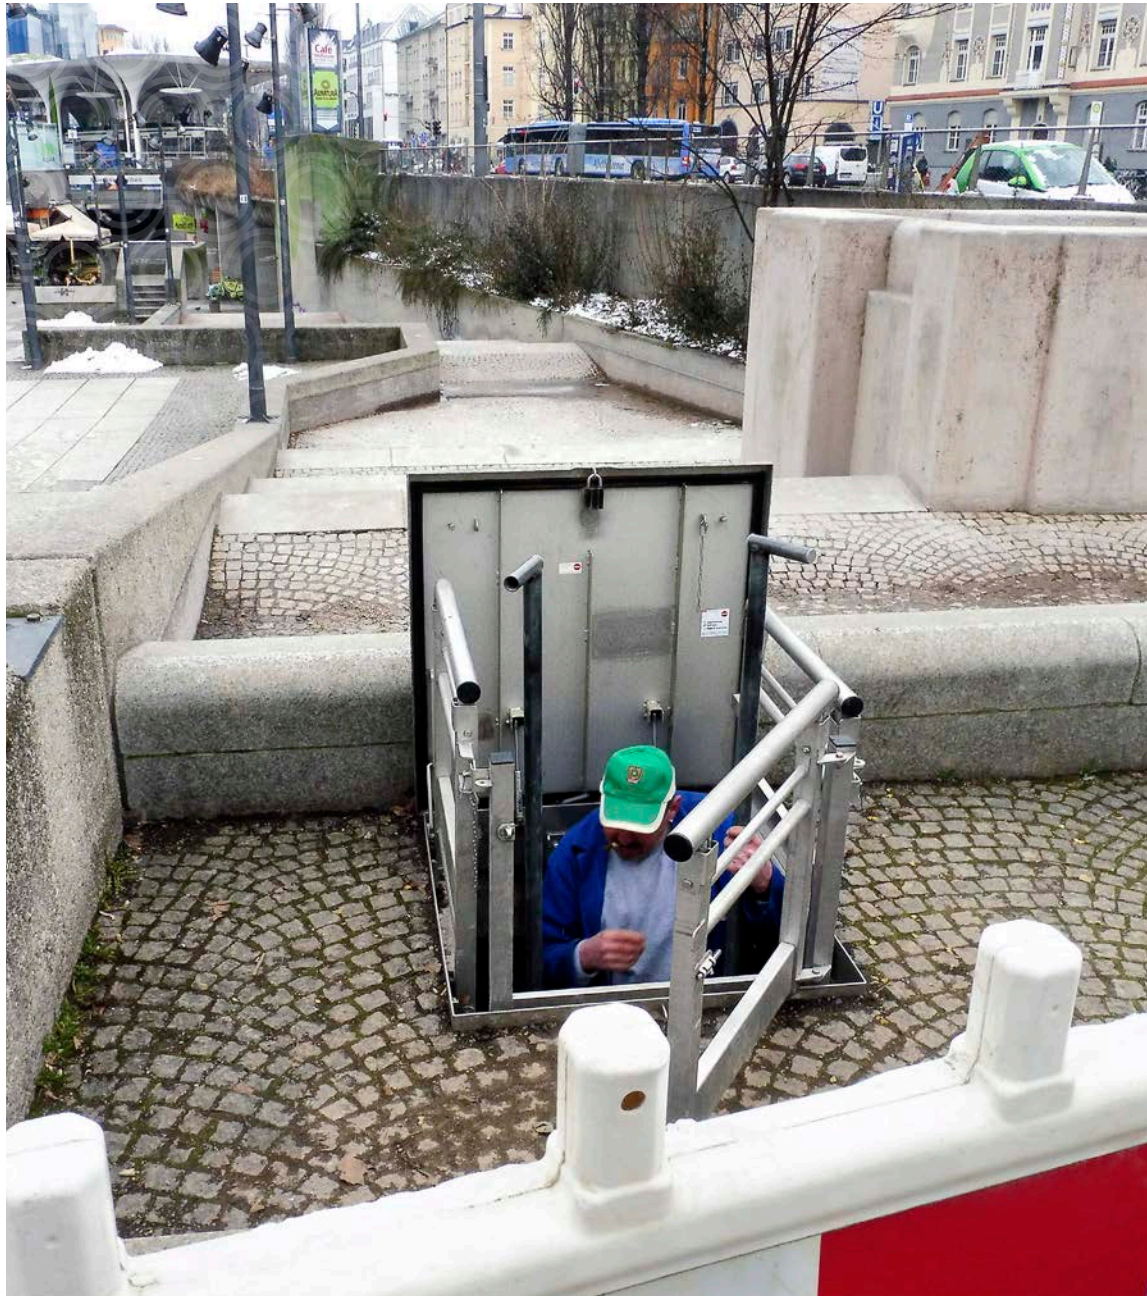
In the summer thousands of tourists and visitors gather around Münchner Freiheit fountains to cool down. But after 40 years, the water pipes were severely corroded and needed to be replaced.

The old pipes were installed six meters below ground level, in very hard to access culverts and shafts. The access to pumps and filters was limited and the new pipes had to fit existing connections. Welding in culverts was out of the question and ductile iron or PE pipes were opted out because of their higher weight.

Alvenius FlowMax pipes solved all these problems and were chosen for the renovation. Alvenius FlowMax pipes are coated with CorroFlo for excellent long term corrosion protection.

For easy access and connection the FlowMax pipes were manufactured in lengths of 3 meters. The pipes low weight, ca 40 % lighter compared to pipes in other material, made the installation quick and simple.
